Hurricane Harvey-Texas

ESF-10

Situation Report #5

Subject: SITREP #5
To: Agency Leads

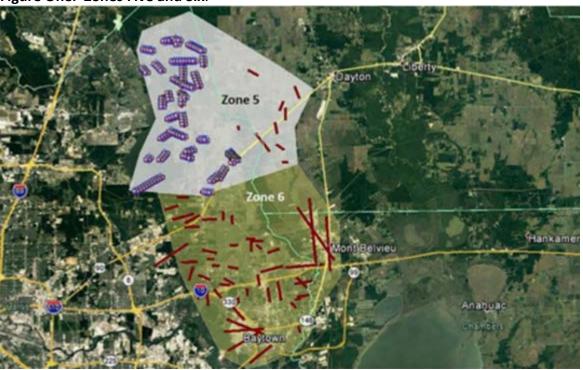
Figure One. Zones Five and Six.

ASPECT flights collected aerial images over several hundred target sites. These targets have been categorized by the ASPECT team into geographic area designated by chronological zone numbers. Figure 1 shows the current zones being surveyed today. Zones 5 & 6 are being flown because of their proximity to the Arkema site.

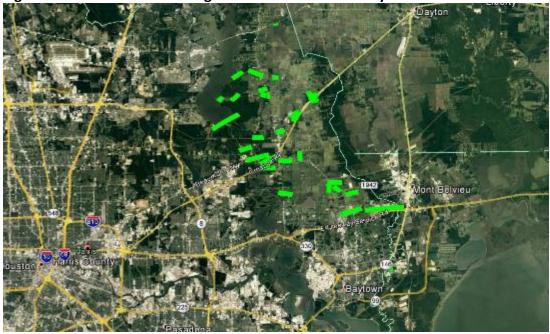
Figure Two. ASPECT monitoring locations in Harris County.

Figure Two shows locations where ASPECT has conducted chemical monitoring in Harris County to date. To date, there have been no confirmed detections over primary targets which are wastewater and drinking water treatment facilities. ASPECT is expected to fly in the Alpha Branch on September 4, 2017.
